FINAL DESIGN REPORT / ENVIRONMENTAL IMPACT STATEMENT

Appendix L – Bridge Information

Highway Project
P.I.N. 1721.51
BINs: 1033141 / 1033142
Interstate 87 (I-87) Exit 4 Access
Improvements
Albany County

BIN 1033141

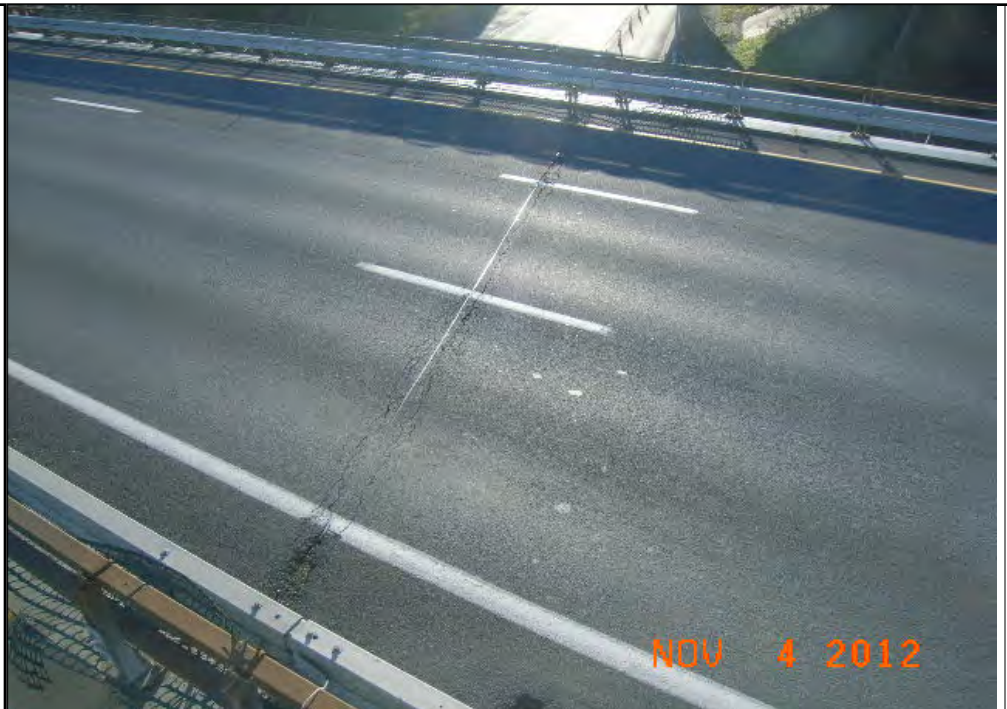
Photo Number: 60

Superstructure - Joints -
Pier 1 above from left

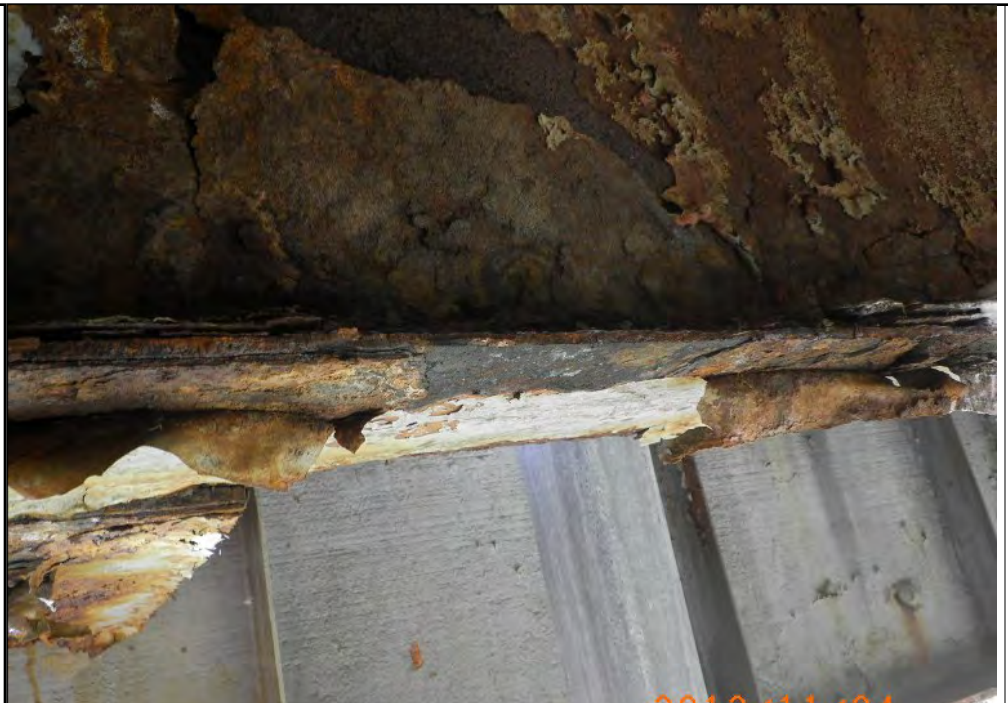
Photo Number: 61

Superstructure - Primary
Members - Span 1 - Bay
1, Panel 4, Intermediate
Stringer

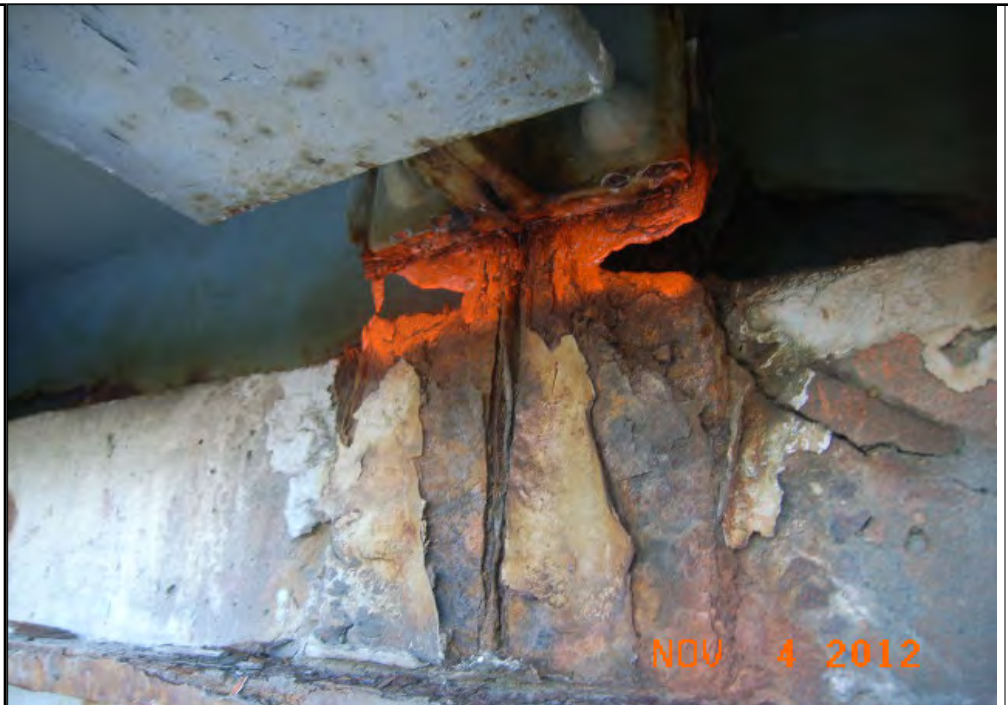
Photo Number: 62

Deck Elements -
Railings - bridge rail post
support steel - Left Fascia
- Begin of Span 2 over
Pier
1 (Spans 1 & 3 similar,
but not as severe)

Analytical review of deteriorated br. rail support system.

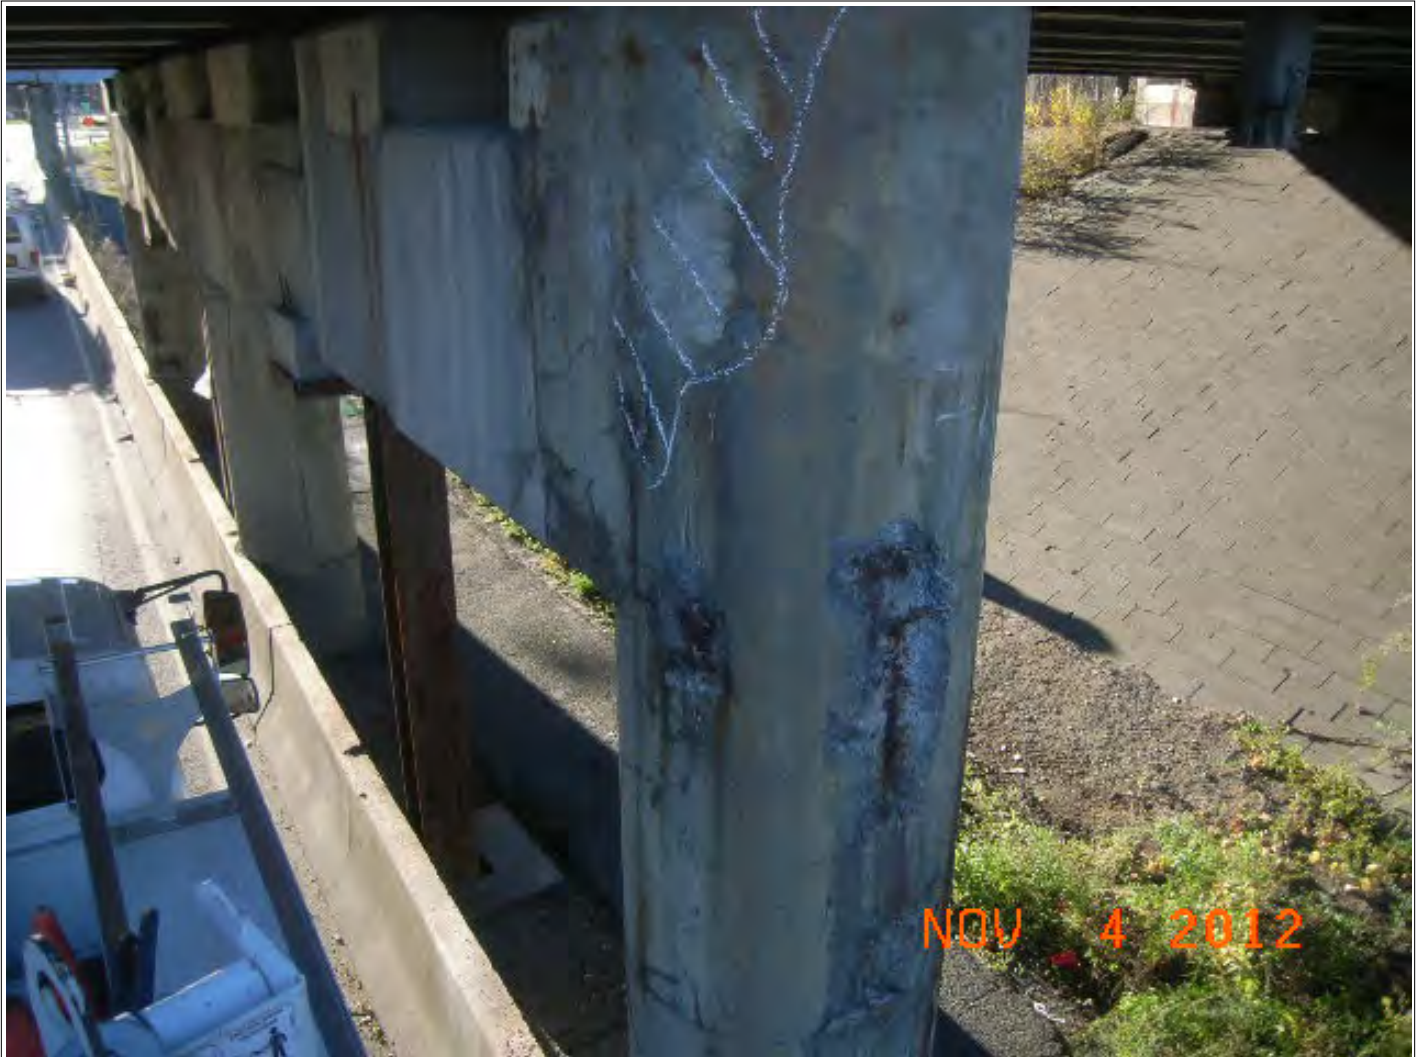
12-6823.JPG - Attached to Yellow Flag 1P120029

YELLOW FLAG 1P120029 (Supersedes Yellow Flag 1T110016)
* * * DETERIORATED PIER CAP BEAM AND COLUMNS * * *

Left face Pier 1

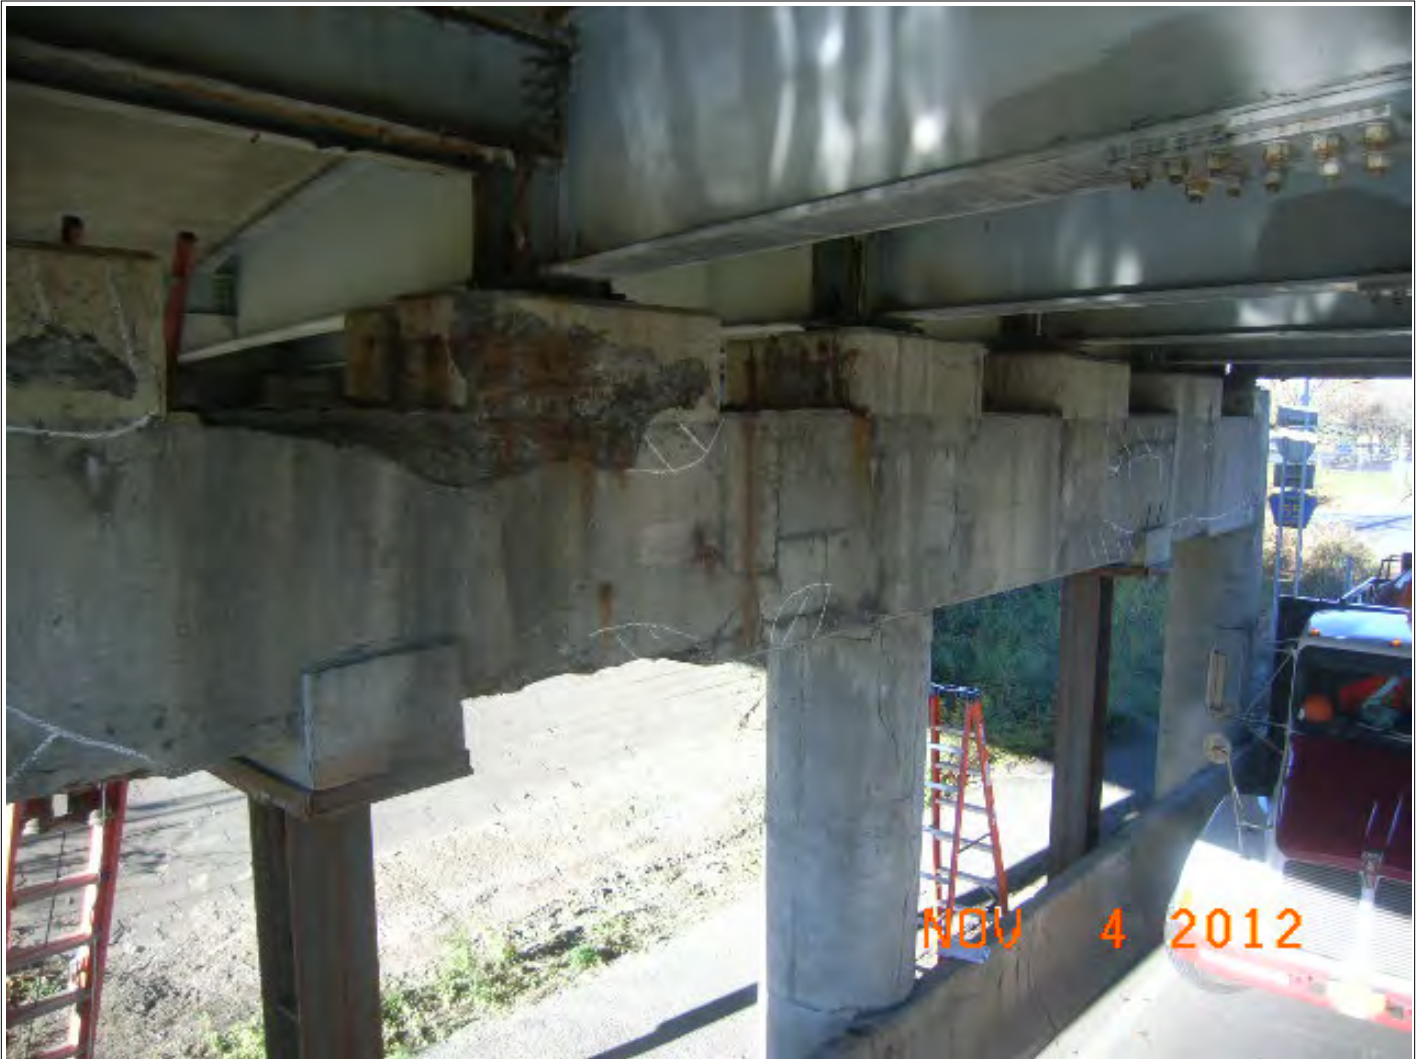
12-6867.JPG - Attached to Yellow Flag 1P120029

- The sides of the cap contain spalled areas
 - o on the End face - a long spall along the top edge from the left edge of Pedestal 5 to the left edge of Pedestal 6 with exposure of a main longitudinal bar, but minimal section loss at this time - photo 12-6867

Overview - End face from Right

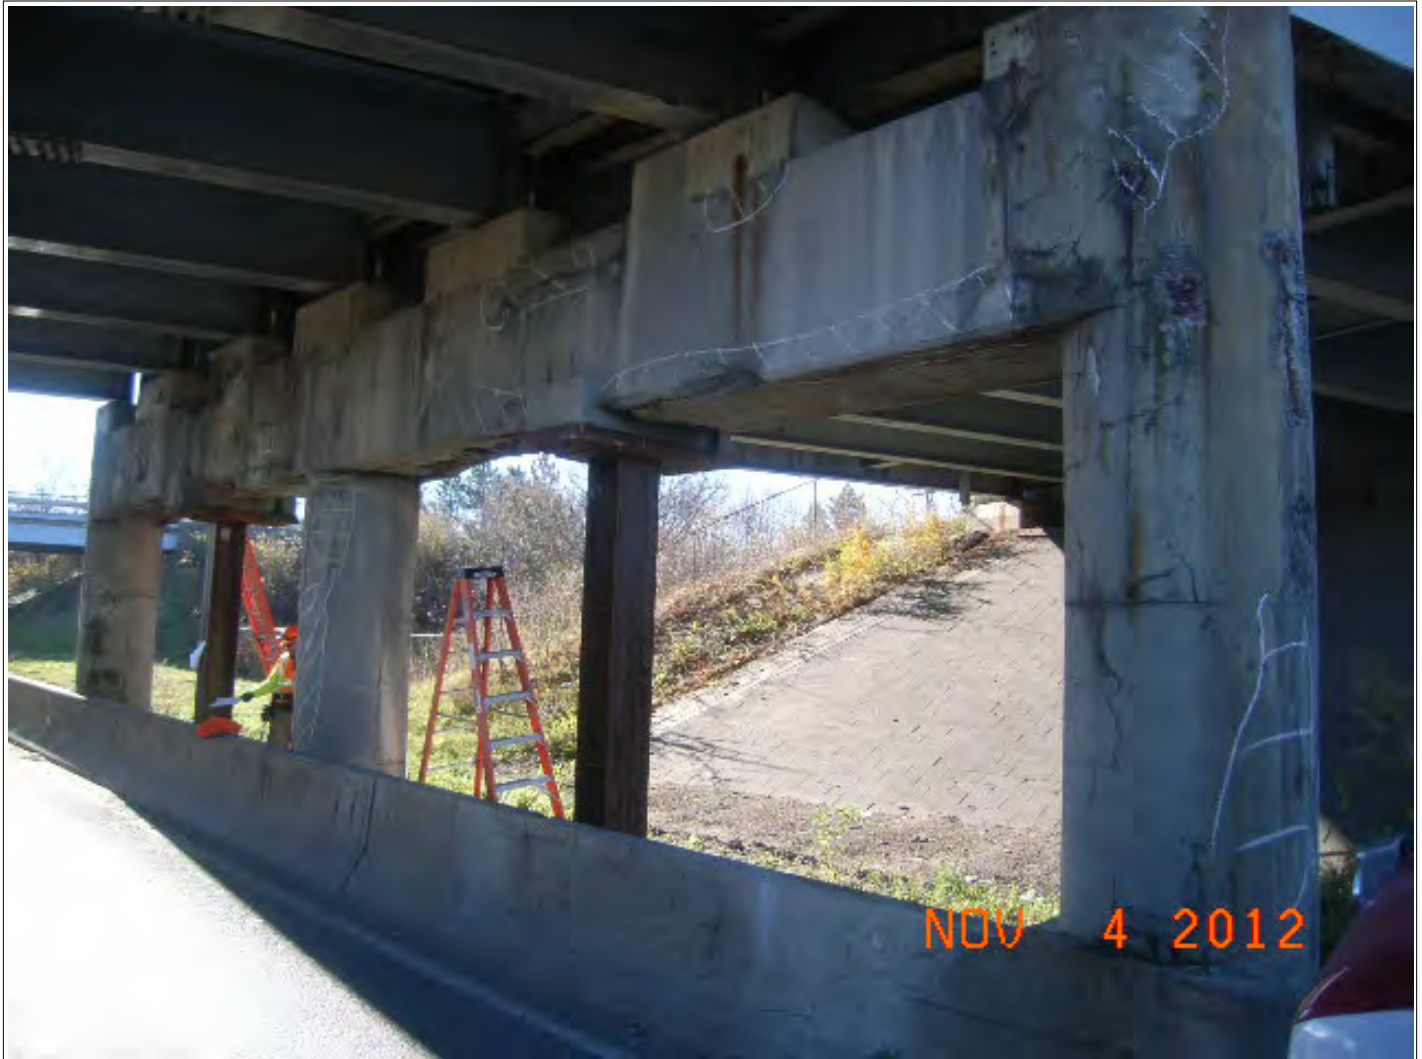
12-6892.JPG - Attached to Yellow Flag 1P120029

- The End faces of all three columns and the outside faces of Columns 1 & 3 contain significant areas of hollow sounding concrete and extensive map cracking for the full height of the columns (photos 12-2816, 6889 & 6892). It is estimated that these conditions affect 15-25% of the face of all three columns.
- There were a few spalls:
 - o Left face of Column 1 - near the top - up to 9 inches wide, 2 ft high, with one exposed rebar - photo 6823
 - o End face of Column 1 - near the top - less than 1 square foot with a stirrup and main bar slightly exposed - photo 12-6823
 - o End face of Column 2 - near its center vertically - up to 9 inches wide and 3 ft high - photo 12-2816.
 - o End face of Column 3 - near the top of the barrier - two areas of up to 1 square foot each with one exposed rebar - photo 12-6888.

Overview - End face from Left

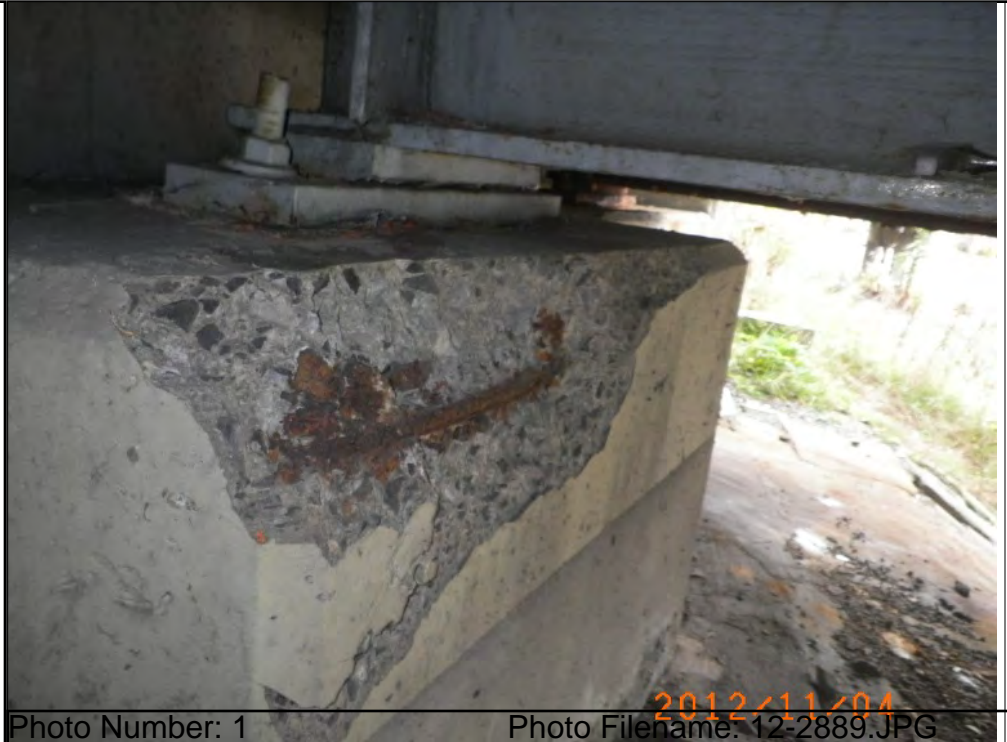
Photo Number: 1

The front right corner of Pedestal 2 was found to be cracked during this inspection and loose concrete was knocked off exposing a horizontal stirrup along the front face. The spalling is across nearly the full width of the pedestal, max longitudinal distance parallel to the beam of about 8 inches, and up to about 15 inches high. The spalling did not reach the corner of the bearing base plate.

Abutments - Seats and
Pedestals - Begin, Ped 2
from right

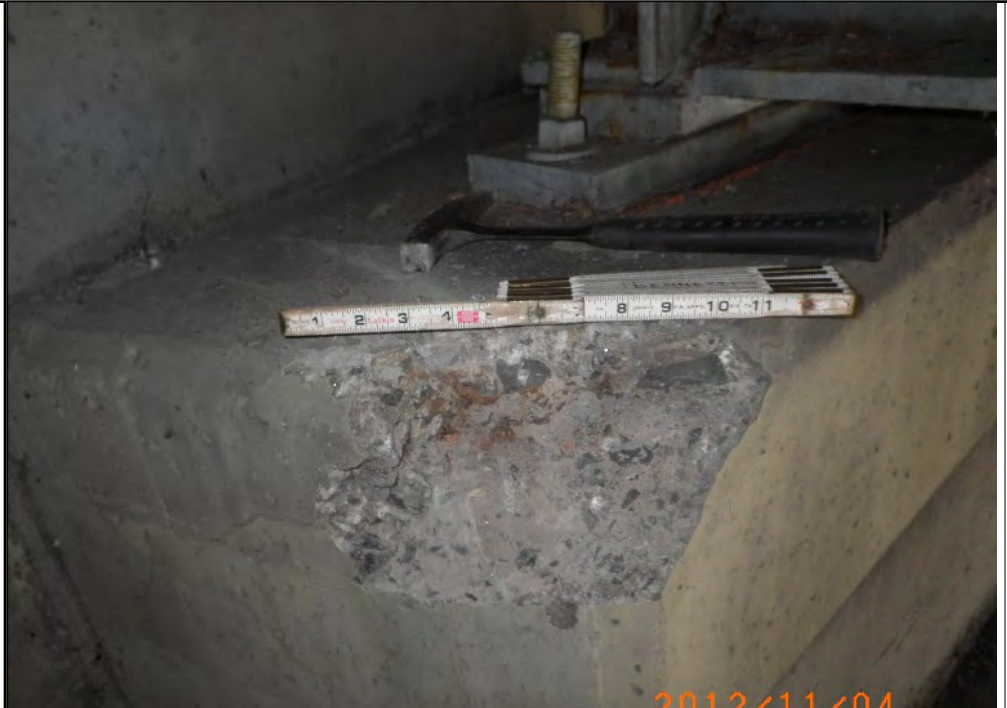
Photo Number: 2

A similar, albeit much less extensive, spall exists at the front right corner of Pedestal 3. The spalling is has a longitudinal distance parallel to the beam of about 8 inches and transverse distance of about 8 inches, and up to about 6 inches high. The spalling did not reach the corner of the bearing base plate.

Abutments - Seats and
Pedestals - Begin, Ped 3
from right

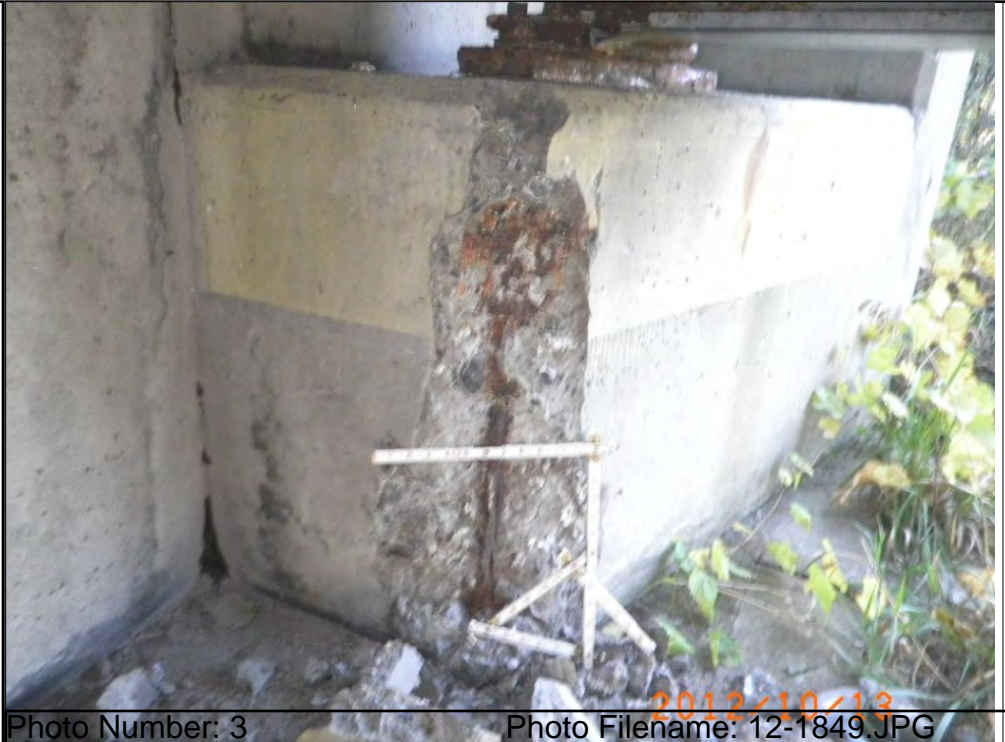
Abutments - Seats and
Pedestals - End, Ped 7

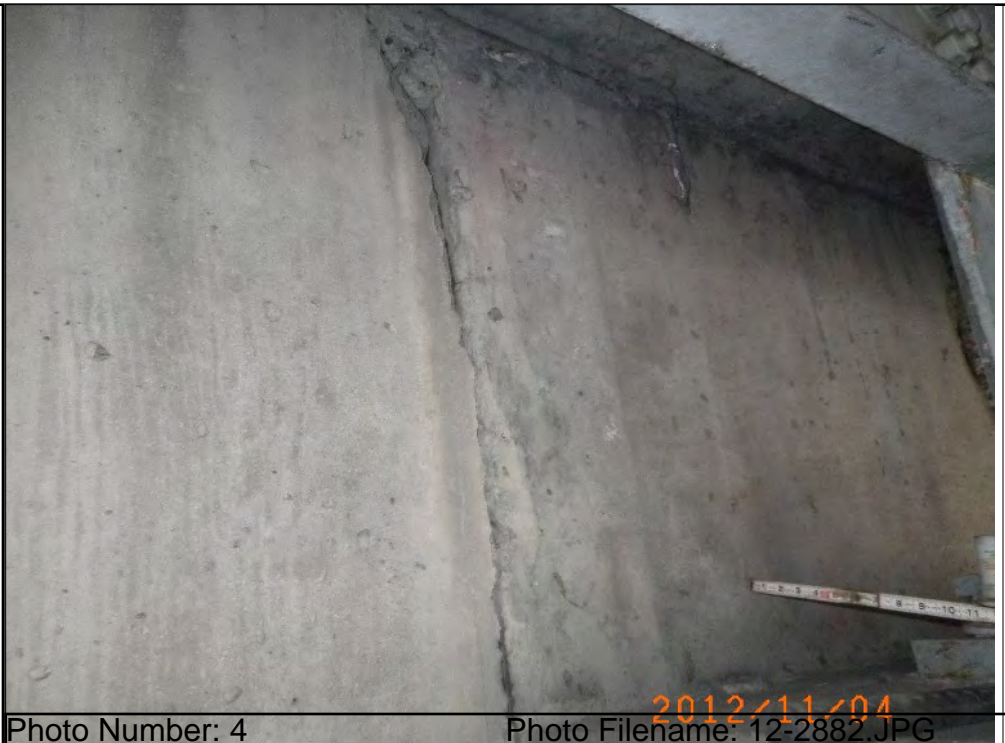
While the bulk of the backwall of the Begin Abutment is in good condition, it is noted that a vertical crack exists generally behind G4 with localized minor spalling along it. Also, there are two spalls - an existing one generally behind G3, above the left corner of the pedestal which has exposed one vertical rebar - total area of about 1 square foot. A second spall was created upon removal of hollow surface material in a similar location behind G4 - somewhat larger, but with an exposed rebar.

Abutments - Backwall -
Begin from G4 looking left

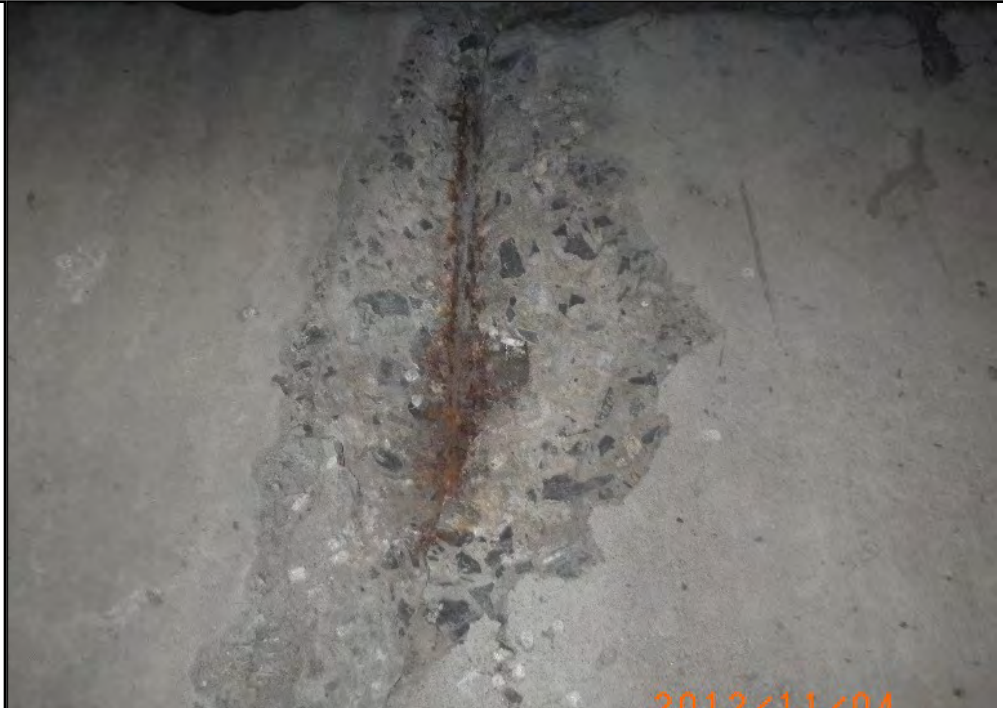
Photo Number: 5

Abutments - Backwall -
Begin G4

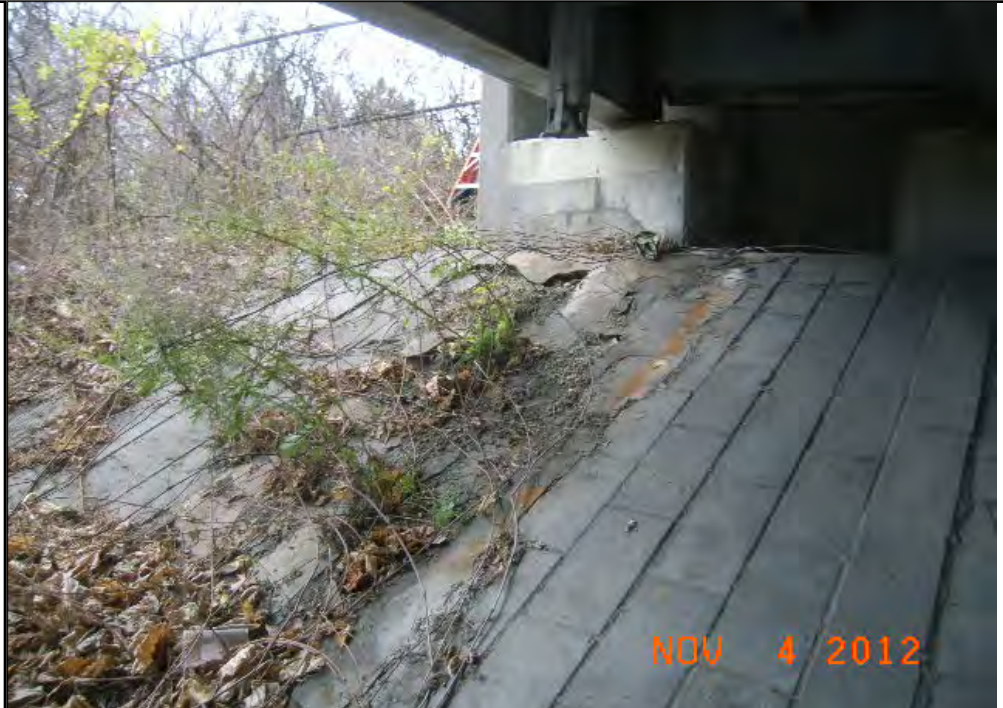
Photo Number: 6

At the Begin Abutment, water draining through both Span 1 scupper downspouts has caused minor erosion of material beneath the concrete block slope protection - Photo 6. The abutment footing is not exposed at either location. The Right side is slightly worse. The remainder of the block pavers are in generally good condition. Rate this condition 5 at this time.

Abutments - Erosion -
Begin Right

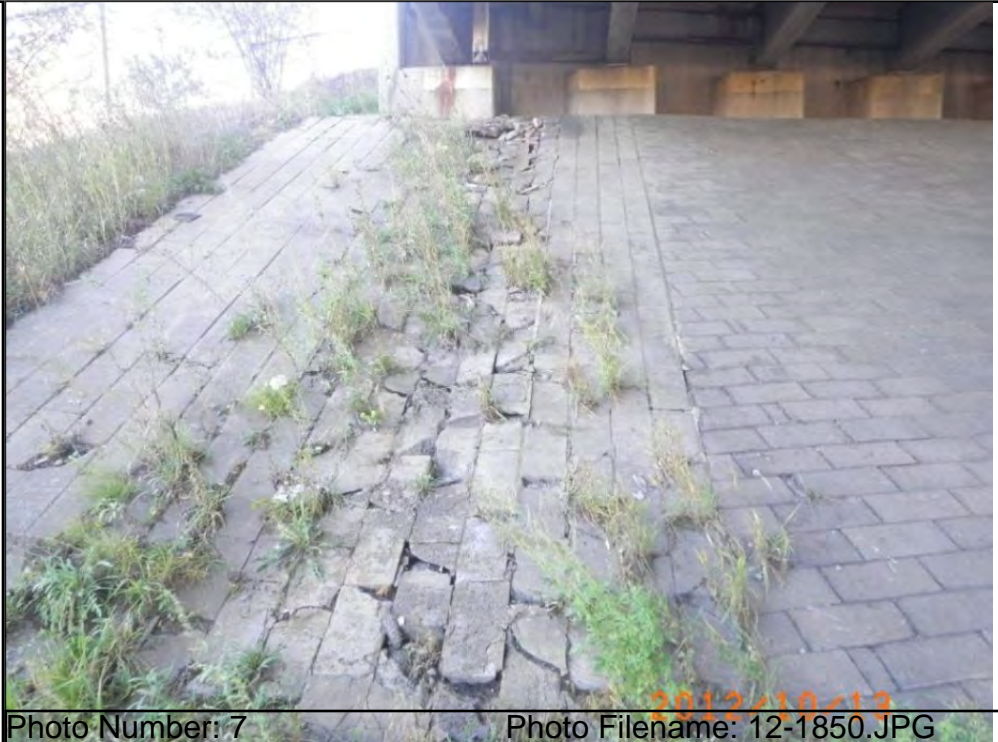
Photo Number: 7

At the End Abutment, water draining through the Span 3 scupper downspout at the End Left has caused erosion of the slope and caving in of the concrete block slope protection - Photo 1850. The undermining of the block at the top of the slope in front of Pedestal 1 has exposed a portion of the concrete footing, which is in good condition. The remainder of the block pavers are in fair condition with areas of block displacement with the worst occurring on the slope in front of Pedestal 7. The footing for the remainder of the end abutment is not exposed and would rate 9.

Abutments - Erosion -
End Left

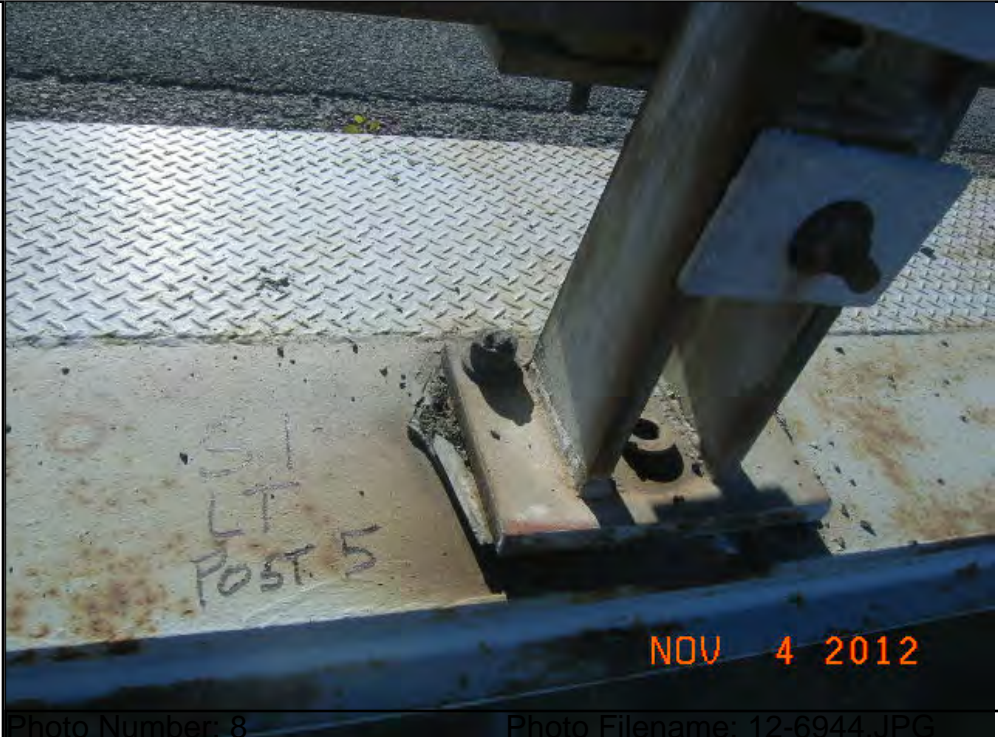
Photo Number: 8

In all 3 spans the bridge rail post anchorages are bolted through a steel plate support structure. There is a build-up of pack rust under the rail post base plates. This pack rust, potentially in combination with other forces, is causing failure of the rear anchor bolt at seemingly random post locations. The nut and shank break off of the bolt at the top of the base plate. There are a total of 3 anchor bolts per post; therefore, loss of one bolt is a significant effect on the capacity of the anchorage system. The bolts remain in place only by rust and friction. At those locations with broken bolts observed during this inspection, the nut and shank portion was missing - potentially having fallen off of the side to ground/roadway below, or onto the shoulder of the bridge deck. Hence, there is a significant risk of bolt pieces falling from Span 2 onto traffic below.

Deck Elements -
Railings - Span 1 - Left -
5th post

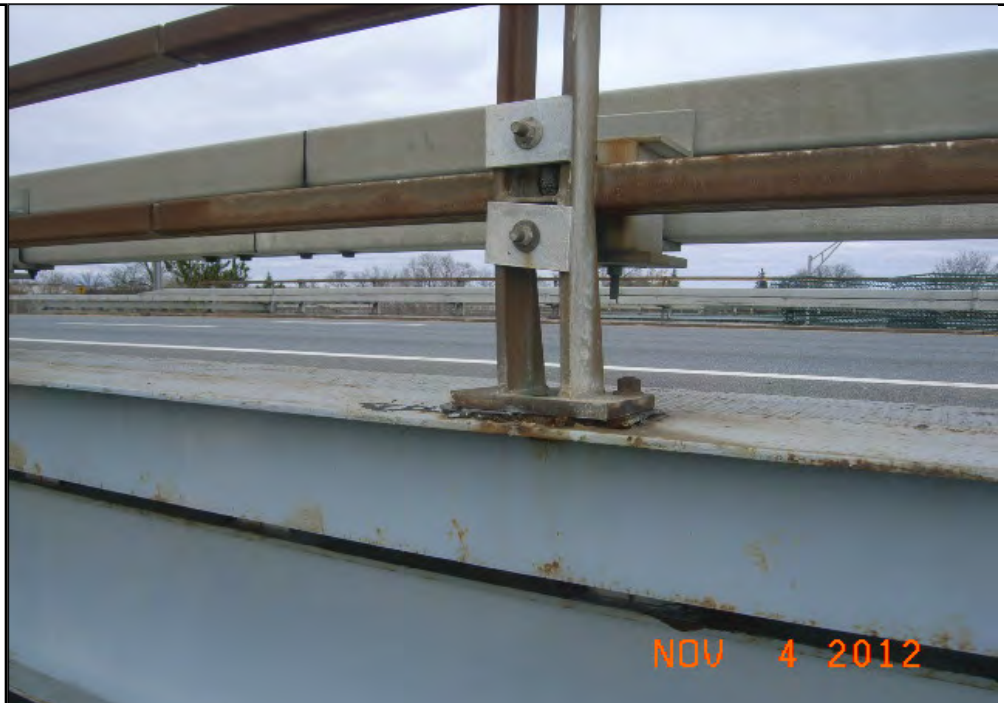
Photo Number: 9

Deck Elements -
Railings - Span 1 - Right -
5th post

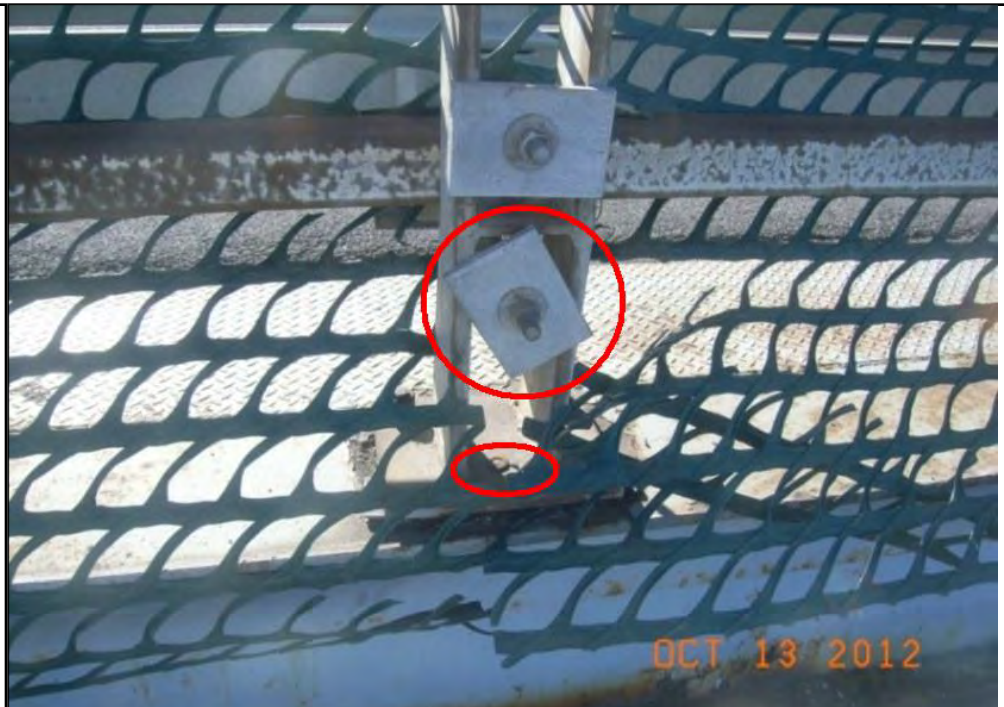
Photo Number: 10

Additionally - the bridge rail has been retrofitted in the past with a pair of box beams in front of the original 2 rail system. The extra box beams are anchored to the posts with bolts and plates on the rear face of the post. In some instances, the plates have become loose and rotated becoming partially or fully ineffective in anchoring the box beam. The following locations were noted:

Span 2, Left side, 3rd post from end - loose plate - Photo 10 <12-5667>.

Deck Elements -
Railings - Span 2 - Left -
3rd post from end

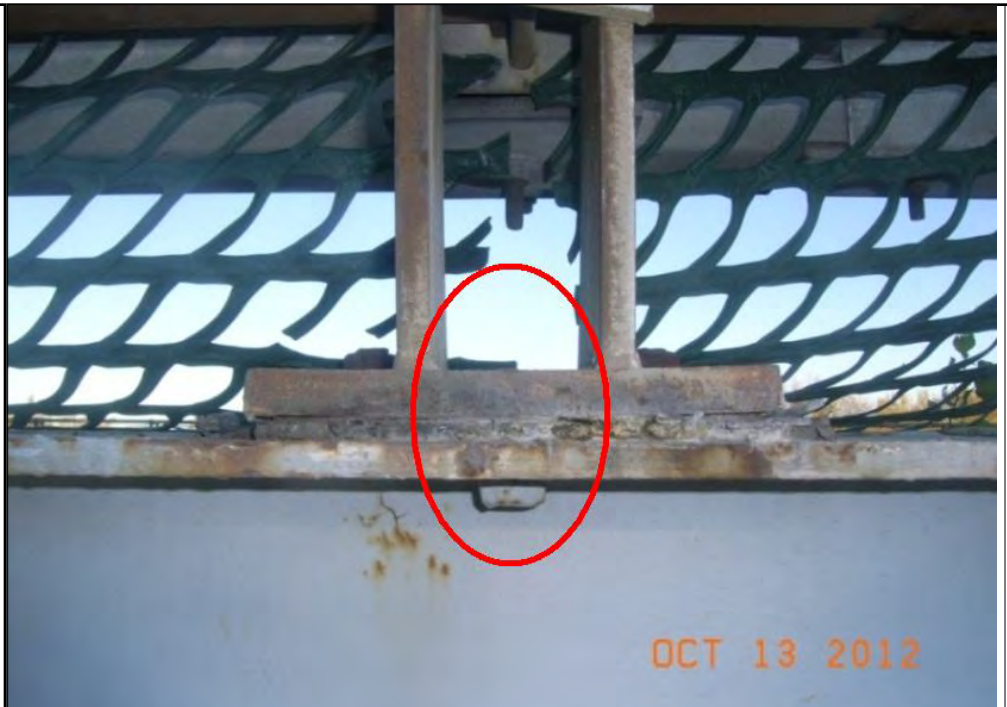
Photo Number: 11

Deck Elements -
Railings - Span 3 - Right -
4th post

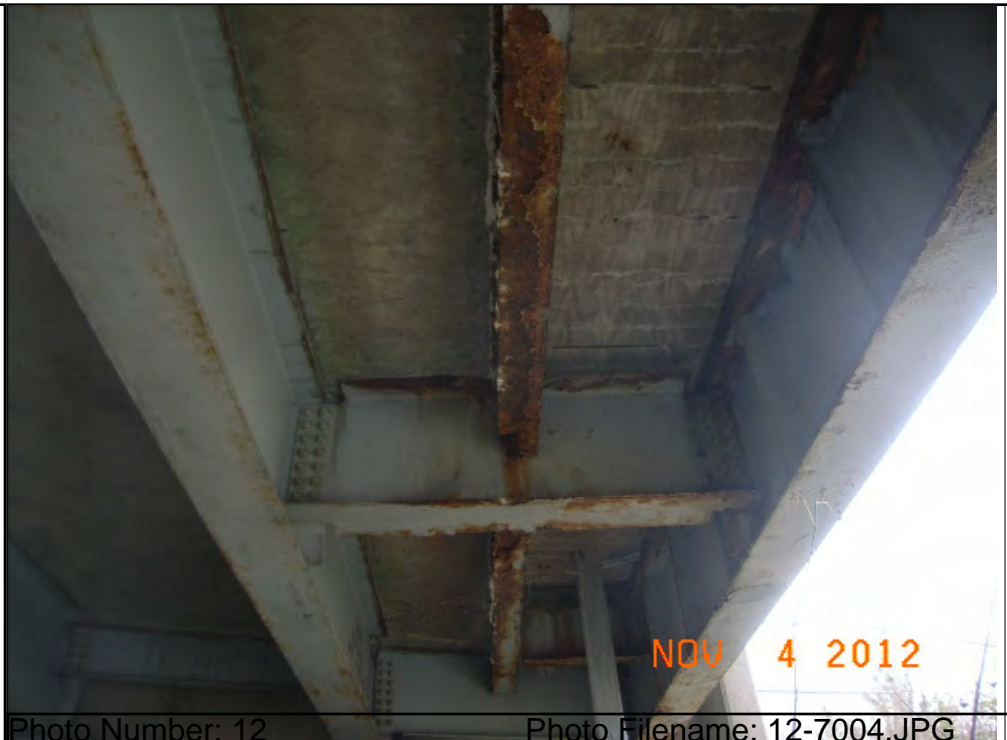
Photo Number: 12

In Spans 1 and 3 where steel grating was replaced with concrete, the concrete deck in Bays 1 and 6 exhibit widespread cracking and deck leakage, as evident by the rust and efflorescence staining with stalactites. Several of the horizontal reinforcing bars are partially exposed with minor section loss. The concrete is hollow sounding at many locations; rates 3. See Photo 12 <12-7004> - Span 1, Bay 1 at begin; Photo 13 <12-1878> - Span 3, Bay 1 at end.

In Spans 1 & 3, the stringers in Bays 1 and 6 that previously supported the open steel grating exhibit moderate corrosion and steel delamination. The worst occurs in Span 1, Bay 1, Panel 1 where the flange thickness has been reduced to 5/16" (nominal flange thickness is 7/16") or 30 percent section loss. The web exhibits steel delamination as well with 5 to 10 percent section loss; rating lowered to 4. See Photo 13 <12-1878> - Span 3, Stringer 2, Bay 1 adjacent to the End Abutment - Span 1 similar - Photo 12 <12-7004>.

Superstructure -
Structural Deck - Span 1,
Bay 1 at begin
Superstructure - Primary
Members - Stringers -
Span 1, Bay 1 at begin
Superstructure - Paint -
Span 1, Bay 1 at begin

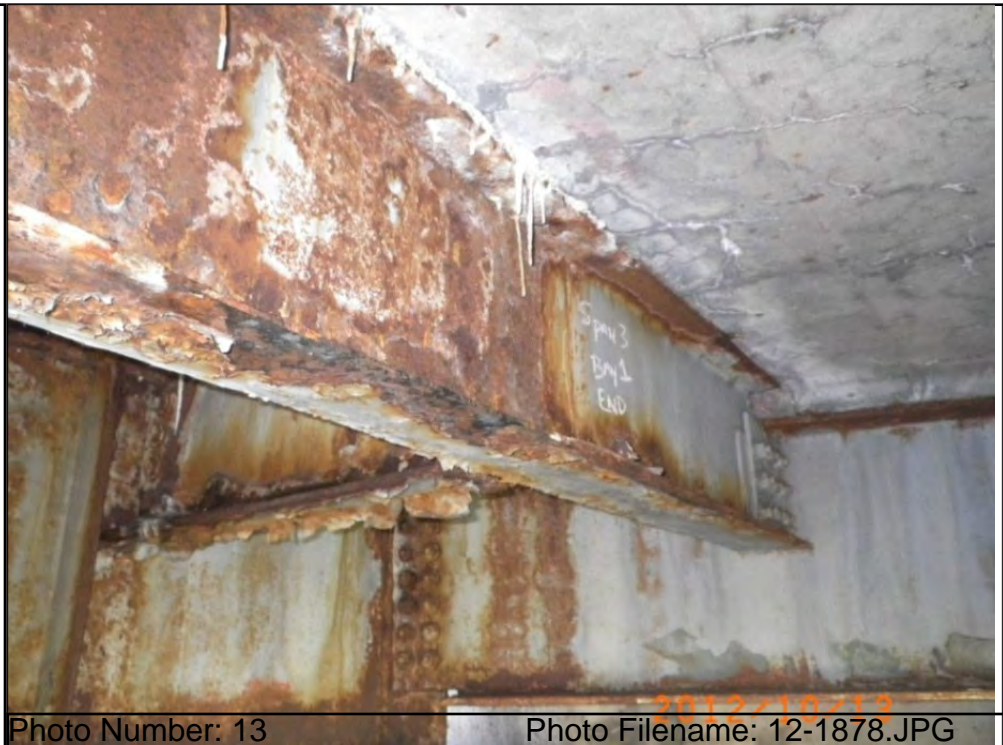
Photo Number: 13

Superstructure -
Structural Deck - Span 3,
Bay 1 at end
Superstructure - Primary
Members - Stringers -
Span 3, Bay 1 at end
Superstructure - Paint -
Span 3, Bay 1 at end

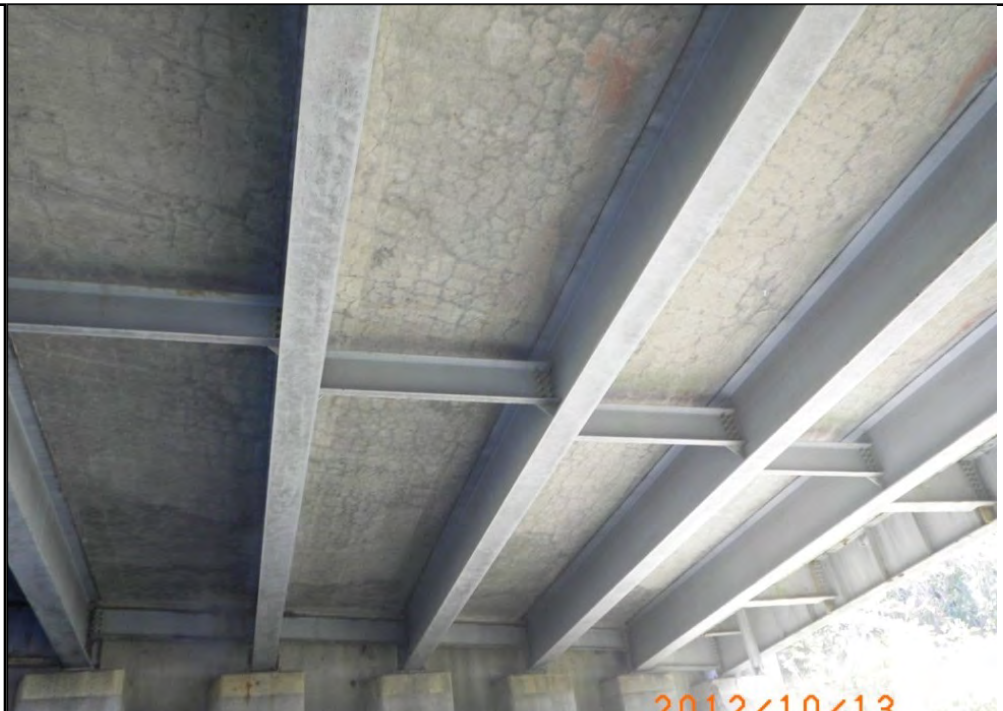
Photo Number: 14

The remaining bays exhibit widespread map cracking with water and light efflorescence staining; would rate 4. See Photo 14 <12- 1881> - middle of underside - Span 3.

Superstructure -
Structural Deck - Span 3 -
middle of span
Superstructure - Paint -
Span 3 - middle of span

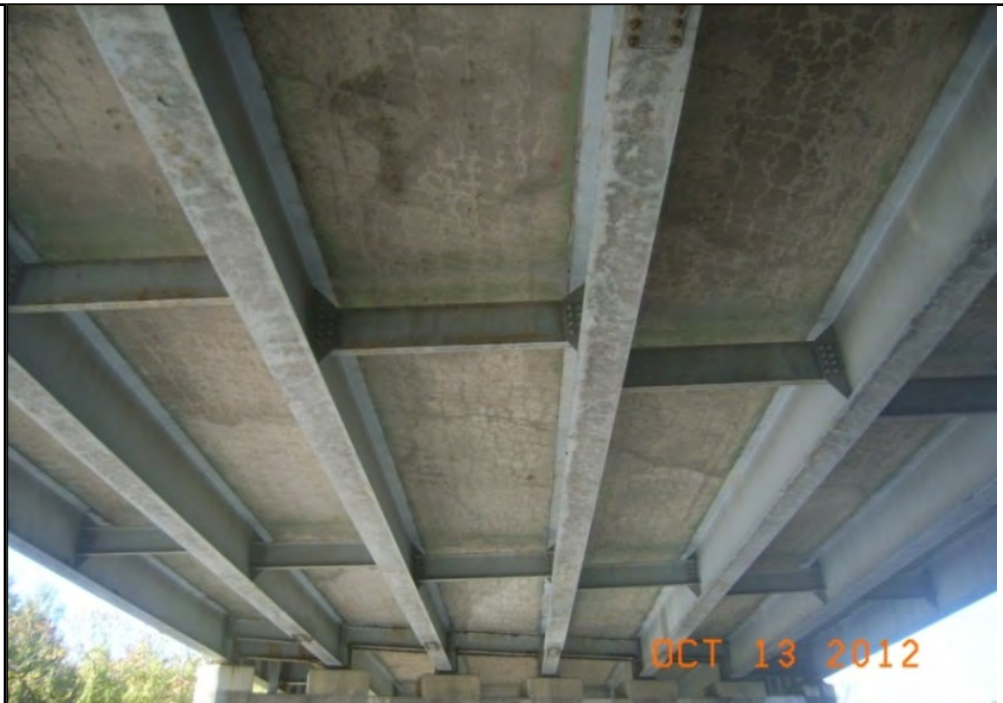
Photo Number: 15

In Span 2, there is widespread mapcracking with water staining and areas of light efflorescence staining; rates 4. See Photo 15 <12-5690> - overall from end.

Superstructure -
Structural Deck - Span 2,
overview from end

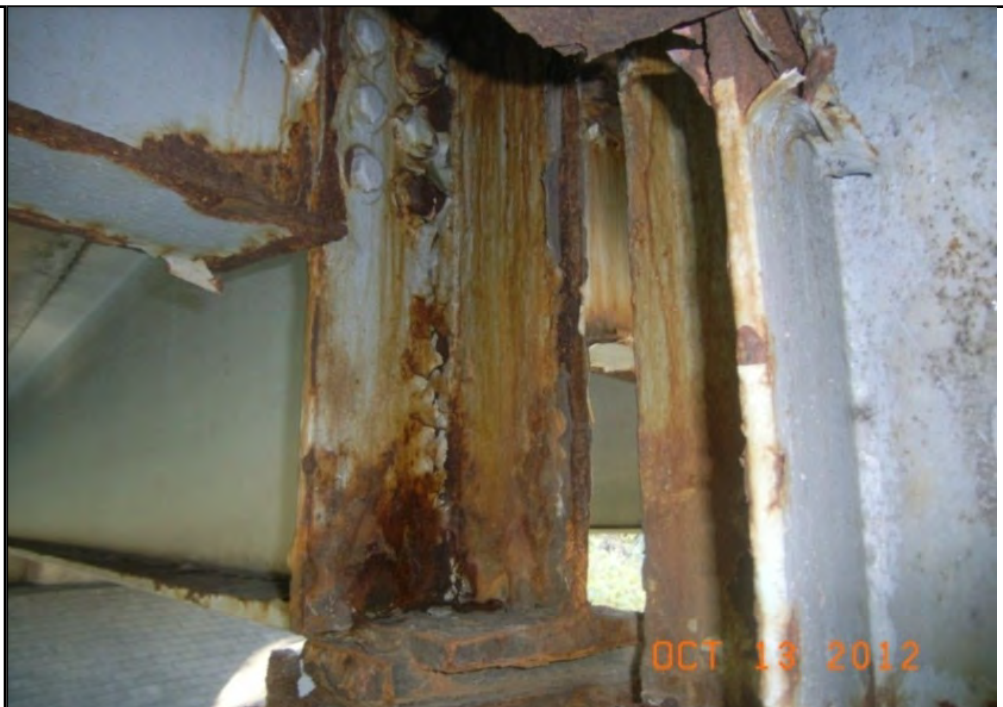
Photo Number: 16

The interior girders would rate 5 due to corrosion at their ends beneath the leaking deck joints. Span 3, Girder 3 at Begin - Photo 16 <12-5649> as example.

Superstructure - Primary
Members - Girders - Span
3 at Pier 2, Girder 3 at
Begin from right
Superstructure - Paint -
Spans 2 & 3 at Pier 2,
Girders 3 from right

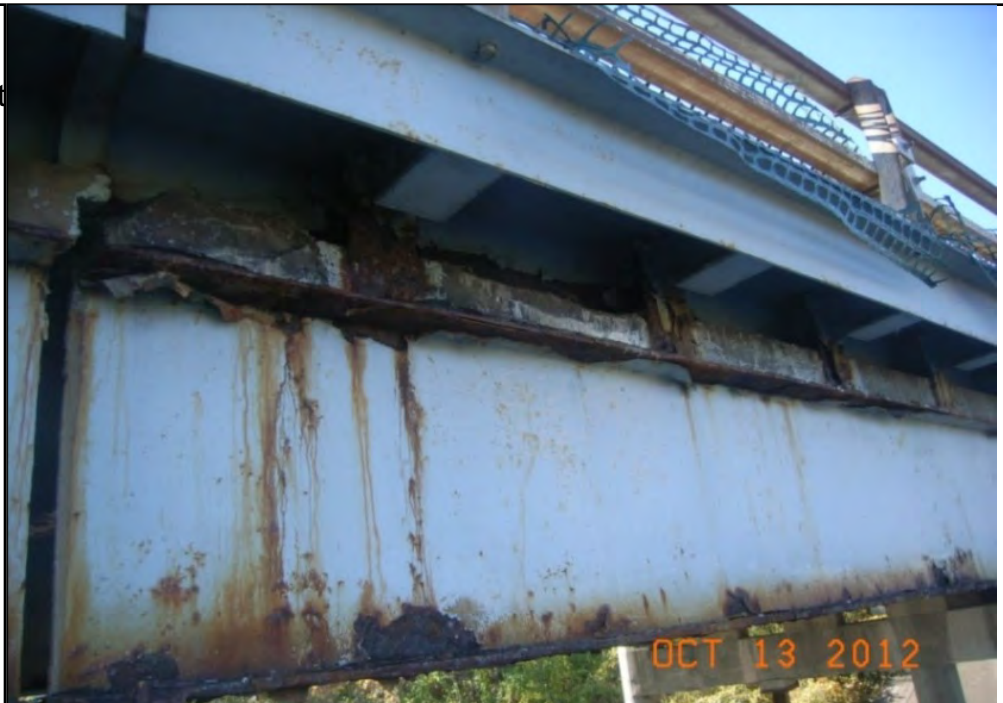
Photo Number: 17

The exterior girders (worst on the Left side along G1) are developing section loss from corrosion primarily along the outside flanges - bottom flange along most of the span - top flanges for shorter distances from each end joint. Span 2, Girder 1, left at end - Photo 17 <12-5677>.

Superstructure - Primary
Members - Girders - Span
2, Girder 1 at End from left
Superstructure - Paint -
Span 2, Girder 1 at End
from left

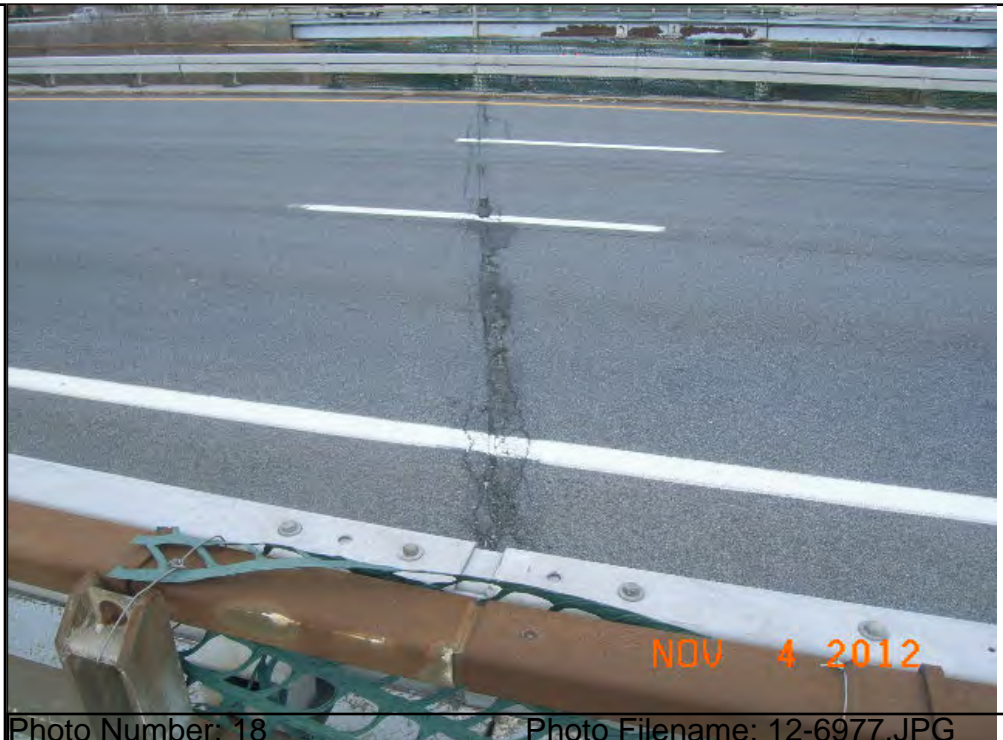
Photo Number: 18

Superstructure - Joints -
Pier 1 - from right

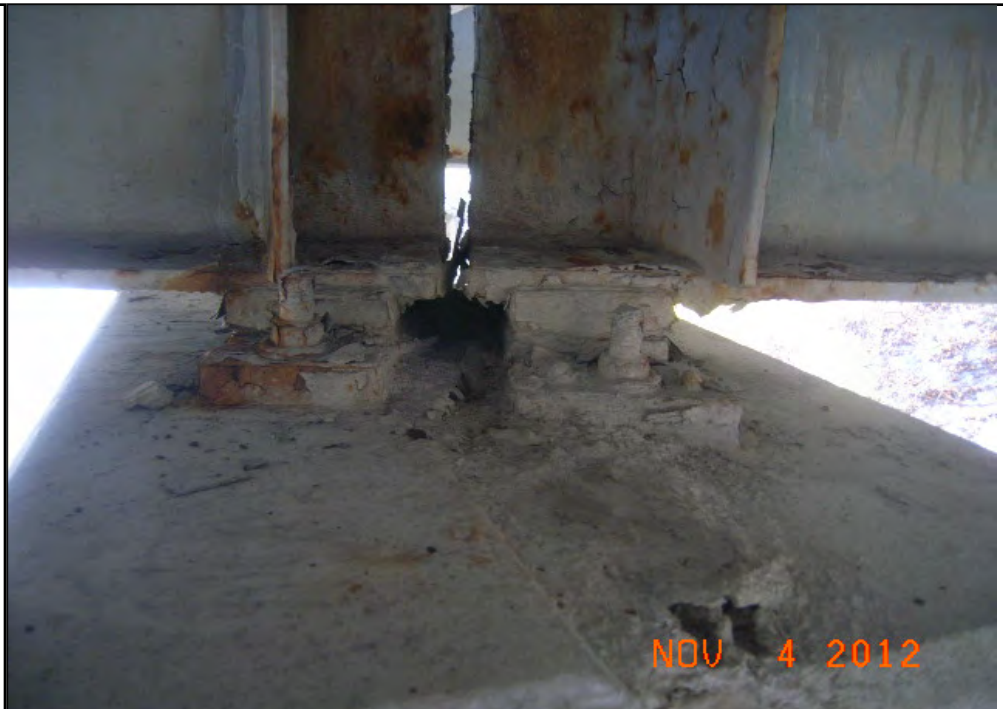
Photo Number: 19

Superstructure - Joints -
Pier 1 - G3 right face
